Information Bulletin No. IB04-005

## **Safety Alert!** **To Pressure Equipment Owners** **and Operators**

### **Valve Failure**

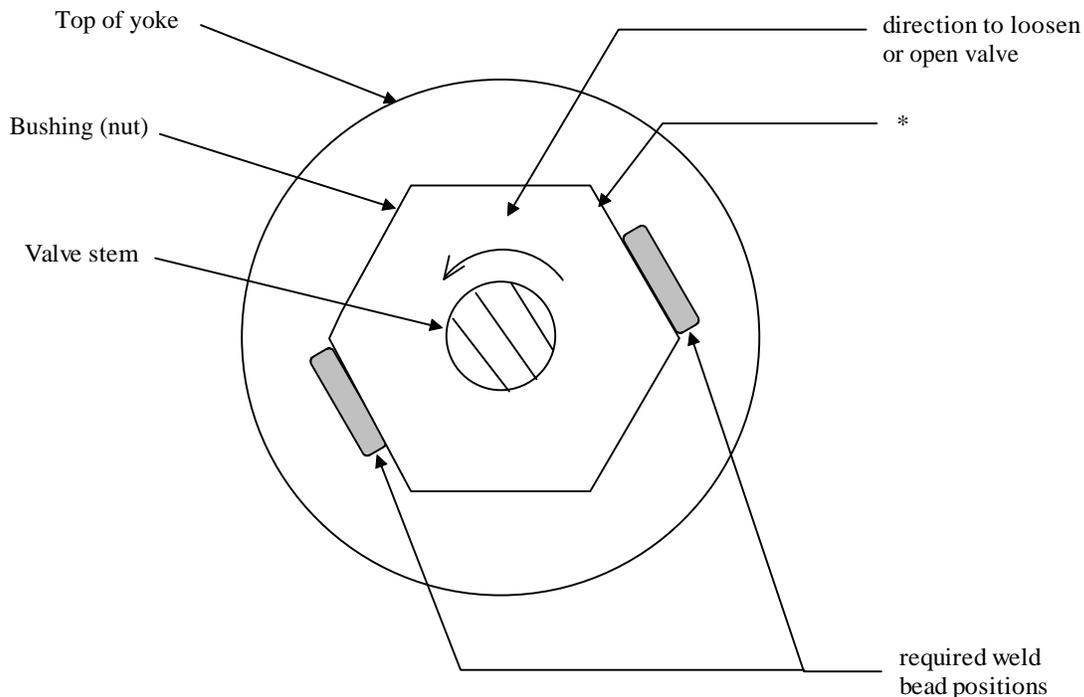
**Top view of an OS&Y type valve**

For the particular valve involved, the manufacturer’s literature indicates that there should be two adequately sized weld beads placed on the top surface of the yoke, adjacent to opposite faces of the hexagonal wrenching surfaces of the bushing. The purpose of these weld beads is to prevent exactly what happened in this case.

The correct location of the anti-rotation tack welds is shown in the sketch below. Unfortunately the valve that failed had the tack weld(s) at the other end of the facet of the hex, as shown by the asterisk in the sketch. Consequently, when torque was applied to the bushing, the facet of the hex rotated away from the weld nugget instead of jamming against it. By the time the facet of the hex contacted the weld nugget, the bushing had already risen a bit, effectively reducing the height of the weld nugget, which may have been below the manufacturer’s recommended height in the first place. As a result, the hexagonal part of the bushing rode up over the weld nugget and the bushing continued to back out of the yoke.

\* On the failed valve, weld was mislocated here and smaller than specified.

1. Review the valve manufacturer's maintenance procedures regarding anti-rotation tack welds or pins and ensure that all safety elements are present.
2. If a valve has been serviced, ensure that the manufacturer's recommended welds or pins have been properly replaced.

3. Review existing installations and stock to ensure that the appropriate anti-rotation tack welds or pins are in place.
4. Instruct operators to be vigilant when opening valves. If there is unusual movement of parts, corrective actions need to be taken immediately. Operators should **never** position themselves in line with the valve stem.
