80,000 NON-ASME PRESSURE VESSELS

Pressure Vessel Explosion

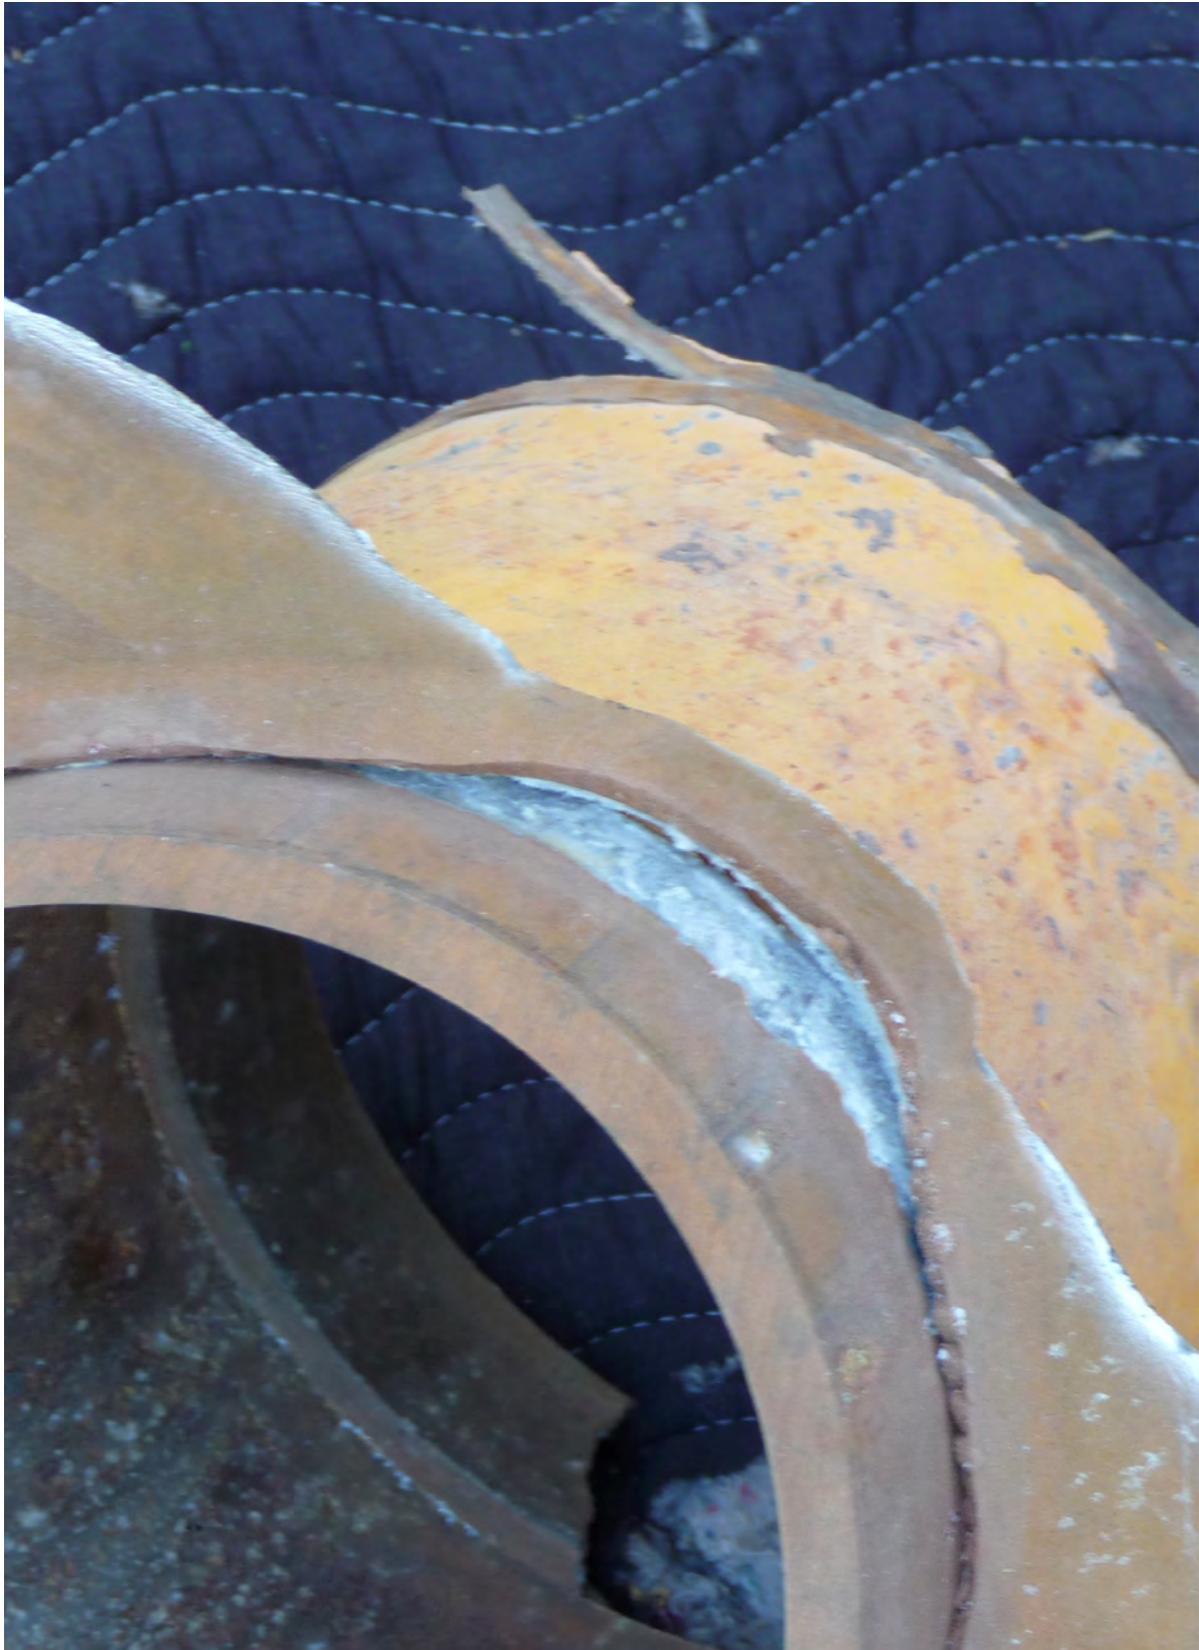
Attachment 5 - Initiation of Failure

My examination and subsequent evaluation revealed that the pressure vessel exploded at a pressure of less than the design pressure, which was 60 psi. The point of failure is located at the top point of the fill nozzle. At this point, the attachment weld is a fillet weld only, on the outside surface of the head. The stress at a point with that type of detail is much greater than the stress in the smooth portion of the head. The stress is significantly increased at that point, because of the unreinforced cut-out area in the torispherical head, and the discontinuity between the head and the nozzle at the fillet weld.

To complicate matters further, the fill nozzles were not properly welded to the head, because they did not use standard welding details required by the ASME Pressure Vessel Code. The Code requires nozzles to be attached using full penetration or partial penetration welds with fillet welds, or fillet welds inside and outside where the nozzle is attached. The Oshkosh vessel only had a single fillet weld on the outside. It is no coincidence that the failure started at the top of the fill nozzle, at the fillet weld, in the area of the highly stressed knuckle. The point of initiation is shown in Attachment 5.

Specifically, the vessel failed to meet basic pressure vessel engineering standards by placing the fill spout in the knuckle region of the torispherical head. A far better and safer location would have been to place the opening in the top portion of the horizontal cylindrical shell. Secondly, the areas surrounding the holes cut for the fill spouts should have been reinforced with doubler plates, or a thicker head plate should have been installed, to comply with ASME Code requirements. To compensate for the material lost when the hole was cut in the vessel, the eight-inch diameter holes required doubler plates of at least sixteen inches in diameter or a thickened head of twice the normal thickness of the head
