Information Bulletin No. IB13-011

### **Salt Bath Heater Incident**

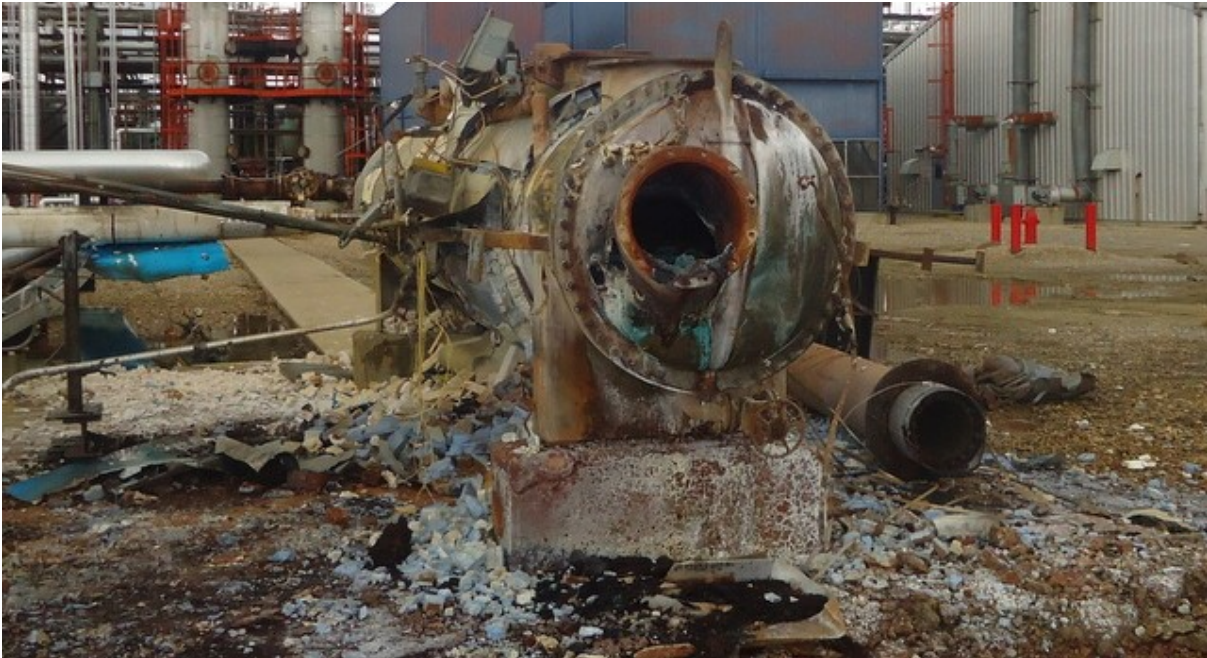
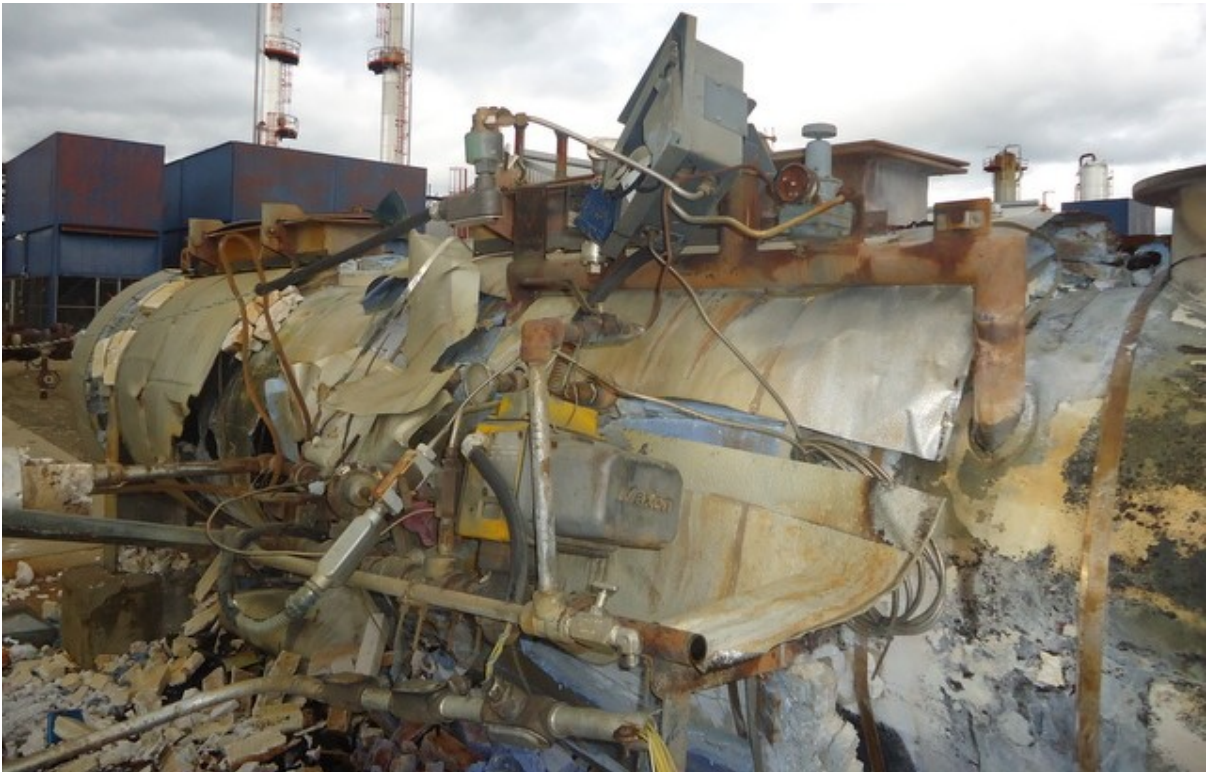
As depicted in the pictures hereunder, we received report in July of a significant explosion of a salt bath heater having occurred at a gas processing facility in Alberta. Shortly after the unit was restarted following routine maintenance and inspection, operators found the unit in an overheated state and proceeded to shut down and isolate it.

The heater reportedly did not appear to be cooling down normally following the shut down, and the explosion occurred soon thereafter. It is unclear as to why the unit did not cool down and it is speculated that a chemical reaction could have happened in the salt bath as a result of the high temperature salt interacting with other substances. A detailed investigation is being undertaken at this time.

Fortunately, this incident only resulted in property damage as all personnel were cleared from the area immediately. There are many similar heaters in use by this company and others in the industry, and these units are operating at increasingly higher temperature because of process needs. This alert is to keep the industry informed that at high temperature the salt can react with other substances such as some metals and material which are part of the process. An explosion can easily lead to far worse consequences as reported in this case.
