Information Bulletin No. IB11-005

**R&M Energy Systems announces product recall of
Hercules® Model 150H BOP (Cap Assemblies Only)**

PRODUCT BULLETIN G0111

Products: Hercules® Model 150H BOP (Cap Assemblies Only)

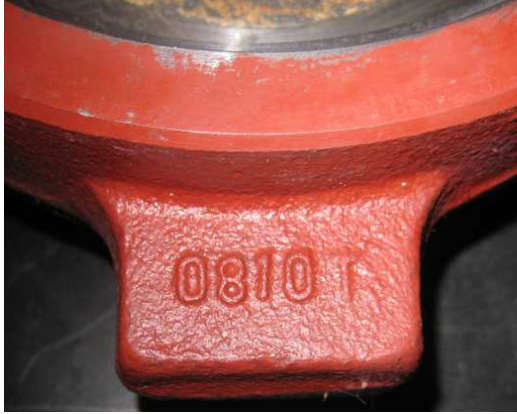
Scope of Recall: Caps with a Manufacturing Date Code “0810T” cast on one of the 3 hammer lugs & supplied to our customers between September 2010 and February 2011. The “0810” designates that these Caps were cast during the month of August 2010.

Required Action: We believe in the best interest of our customers safety that they should immediately inspect all 150H BOPs **received or installed after Aug. 31, 2010 & before March 1, 2011** to see if any of the Caps have manufacturing Date Code “0810T” on one of the 3 hammer lugs as shown in the photo on the next page:

CAUTION: prior to inspecting a 150H BOP on an existing well installation, the pumping unit must be shut off using appropriate Lock-Out/Tag-Out procedures and the internal pressure must be bled off. Any Cap discovered with this date code can be easily removed as follows:

- A. Back ram screws out until they stop turning & then run them in approx. 6 turns.
- B. Using a 2 lb. "Dead Blow" Hammer or 1 - 2 lb. brass hammer strike a hammer lug in CCW direction until Cap is free to rotate by hand, and then unscrew Cap Assembly.
- C. Lower the Cap Assembly enough to allow ram screw to fully disengage from slot in the back end of ram.

If a 150H BOP is discovered with Caps having date code 0810T, only the Cap Assembly needs to be returned to R&MES for free replacement. There is no need to remove the BOP from an existing installation or to return a BOP assembly that is still on the shelf.
